# Manhole Inspection Summary

Manhole # S15C1\_017MH

**Location** Address: **2930 JAMES ST** Cross Street: **INVERNESS AV**

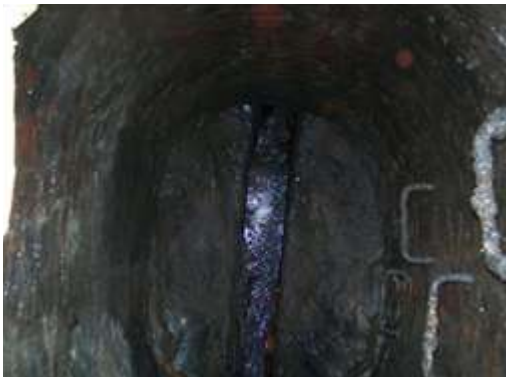
Defect 3

Infiltration: ☐ None ☐ Joint ☐ Cracks ☐ Mortar ☐ Roots ☒ Wall

**Steps** Count: **4** Missing: **0** ☒ Corroded

corroded steps; Barrel and Corbel Infiltration from walls

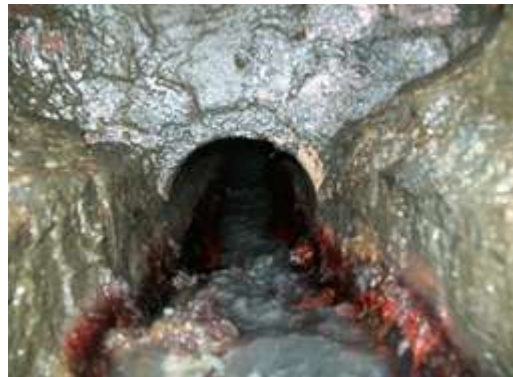
Defect 2

Condition: ☐ Sound ☐ Cracked ☐ Root Intrusion ☐ Loose Brick ☒ Deteriorated

Barrel Deterioration and Infiltration

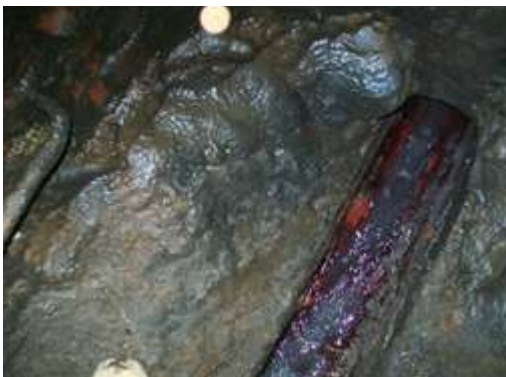
Defect 1

Condition: ☐ Sound ☐ Cracked ☐ Root Intrusion ☒ Deteriorated ☐ Leaks ☒ Debris

Condition: ☐ Sound ☐ Cracked ☐ Root Intrusion ☒ Deteriorated ☐ Leaks ☐ Debris

Debris on Bench, Deteriorating Bench and Channel

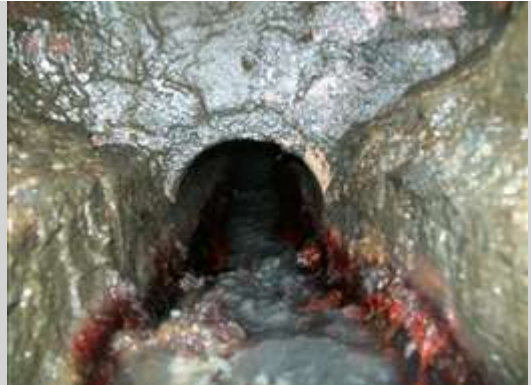
12 O'Clock Outflow

8 in. Circular Gravity Sewer  
Pipe Out @ 12 O'Clock

Pipe Height: **8.4** (in.) Rod and Bar (Angled)  
Pipe Material: **Clay** ☐ Pipe Lined  
Invert Depth: **9.18** (ft.) Flow Characteristics: **Slow**  
Deposits: ☒ None ☐ Mud ☐ Sludge ☐ Debris ☐ Grease  
Silt Depth: **0** (in.) Deposits Extent:  
Infiltration: **None** Pipe Seal Cond: **Sound**

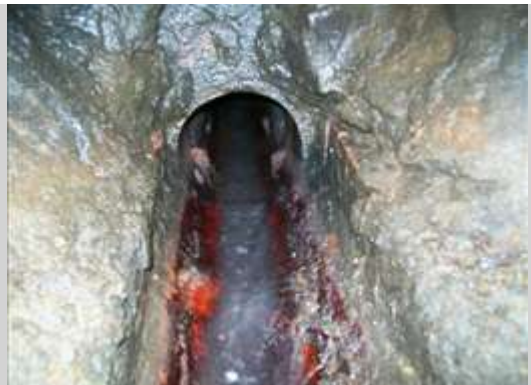
6 O'Clock Inflow

8 in. Circular Gravity Sewer  
Pipe In @ 6 O'Clock

Pipe Height: **8.4** (in.) Rod and Bar (Angled)  
Pipe Material: **Clay** ☐ Pipe Lined  
Invert Depth: **8.92** (ft.) Flow Characteristics: **Slow**  
Deposits: ☒ None ☐ Mud ☐ Sludge ☐ Debris ☐ Grease  
Silt Depth: **0** (in.) Deposits Extent:  
Infiltration: **None** Pipe Seal Cond: **Sound**
